## **Asbestos Inspection**

### **WVLSC**

**Inspection Location  
183 N Bradshaw Street  
Belington, WV 26250**

November 2023  
T70-11422

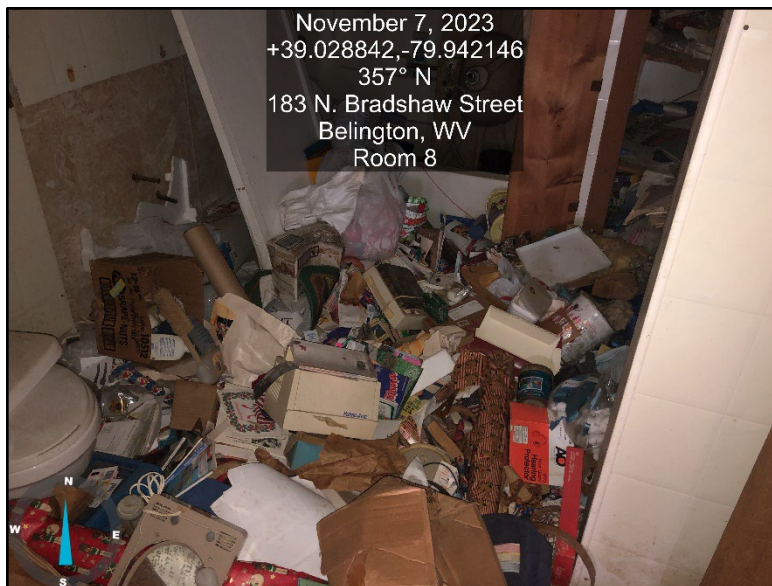
**Photograph # 12**  
Room 8

LOCATION	Sample #'s	MATERIALS	ASBESTOS %	QUANTITY	Friable/ Non-Friable
Room 8	17, 18	Orange Laminate	25%	110 SQ FT	Non-Friable
Exterior of Room 10	34	Tar Siding Layer 3	10%	40 SQ FT	Non-Friable

CLIENT ID #:	LAB ID #:	LOCATION:	COLOR:
183-17	23B-36307	Room 8	Orange
Texture/Description:	Solid/Laminate	Chrysotile: 25%	Tremolite: 0% Anthophyllite: 0%
TOTAL ASBESTOS:	25 %	Amosite: 0%	Actinolite: 0% Crocidolite: 0%
Cellulose: 0 %	Fiber Glass: 0%	Others: 0%	Filler/Binder: 75 %

CLIENT ID #:	LAB ID #:	LOCATION:	COLOR:
183-18	23B-36308	Room 8	Orange
Texture/Description:	Solid/Laminate	Chrysotile: 25%	Tremolite: 0% Anthophyllite: 0%
TOTAL ASBESTOS:	25 %	Amosite: 0%	Actinolite: 0% Crocidolite: 0%
Cellulose: 0 %	Fiber Glass: 0%	Others: 0%	Filler/Binder: 75 %

The Town of Belington plans to demolish the structure. Samples taken from specific locations were representative of the homogenous materials found within the identified areas.

Any materials found hidden in such inaccessible areas during the demolition project and not listed in this report, must be sampled by a WV Licensed Asbestos Inspector.

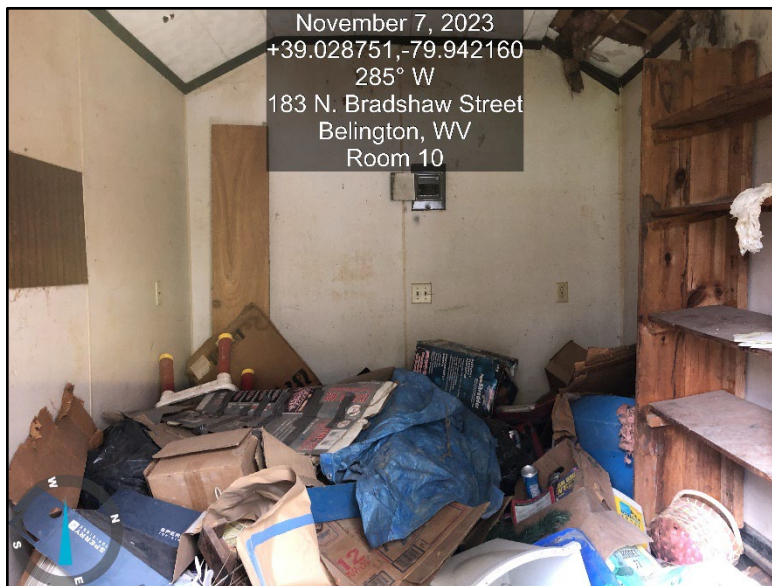
**Photograph # 14**  
Room 10

<b>CLIENT ID #:</b>	<b>LAB ID #:</b>	<b>LOCATION:</b>	<b>COLOR:</b>
183-34	23B-36324	Layer 3 Room 10	Black
Texture/Description: Solid/Tar Siding		Chrysotile: 10%	Tremolite: 0% Anthophyllite: 0%
TOTAL ASBESTOS: 10 %		Amosite: 0%	Actinolite: 0% Crocidolite: 0%
Cellulose: 15 %	Fiber Glass: 0%	Others: 0%	Filler/Binder: 75 %
